# Cornell University

## AgriTech Campus in Geneva, NY

### Electrical Master Planning, Substation, Distribution and Building Service Entrance Upgrades

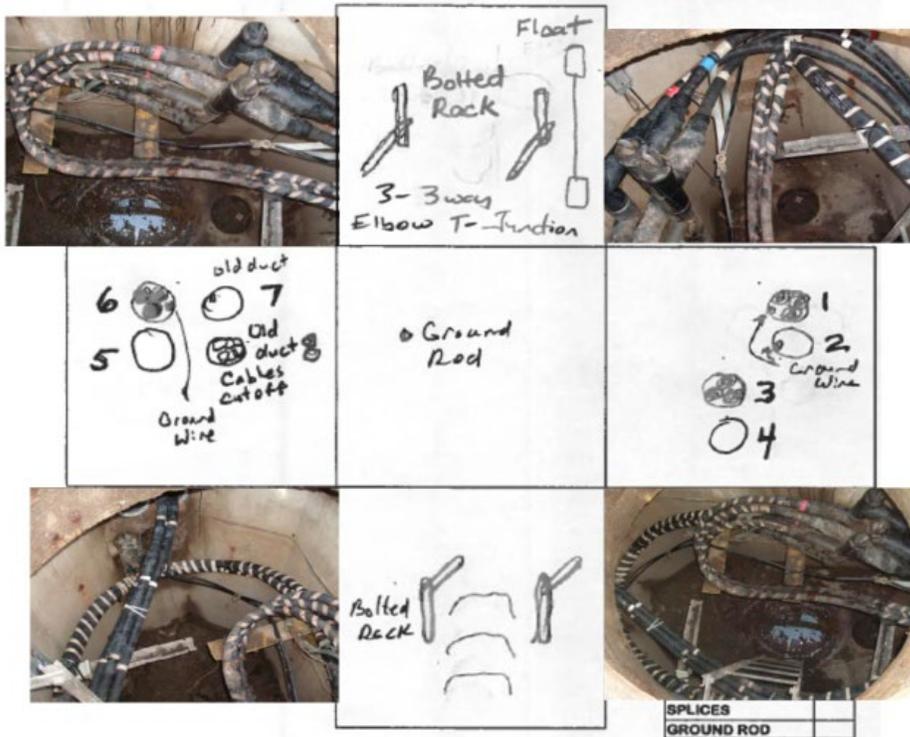
MANHOLE:		MANHOLE CONDITIONS AND PROBLEMS:	
INSP. DATE		Fair to Good Condition	
INSP. BY		RACKING TYPE & CONDITIONS:	
LOCATION:		Bolted on Racking Good Condition	
SUMP	YES / NO	GROUNDING & CONDITIONS:	
DRAIN	YES / NO	GROUND ROD	YES / NO
WATER LEVEL	WET	RING GROUND	YES / NO
DIMENSIONS		STRUCTURAL CONDITIONS:	
RING DIAMETER		EXPOSED REBAR	YES / NO
FLOOR TO CEILING		CHIPPING CONCRETE	YES / NO
THROAT

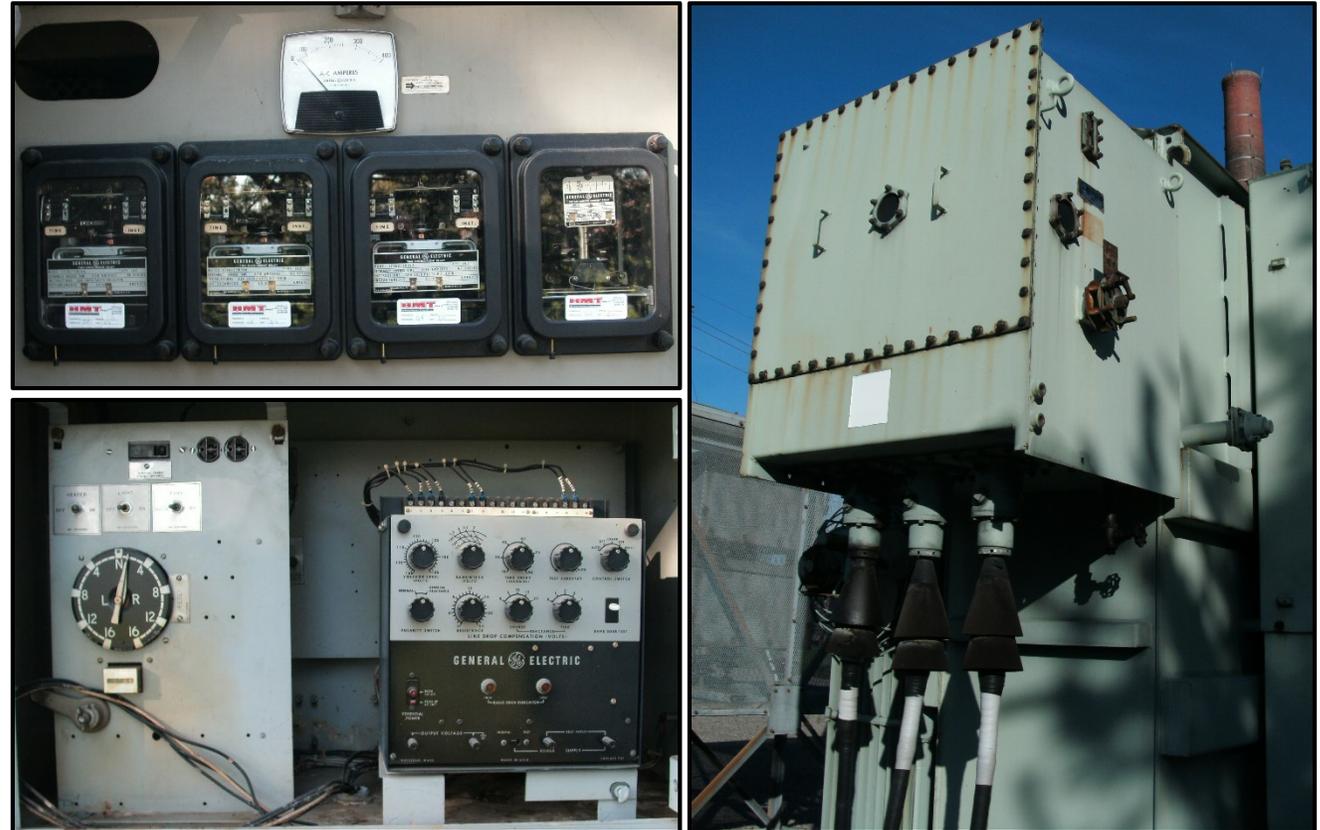
- Equipment age of ~50 years, past expected life.
- 34.5kV switch marked 'Do Not Operate', manufacturer instruction.
- Transformer:
  - On-load tap changer (OLTC):
    - Monitored change counter.
  - Infrared identified some radiator blockages.
  - ~40% peak loaded.
- 4.8kV switchgear:
  - Old electro-mechanical relays – lack of coordination.
  - One breaker unable to electrically switch.

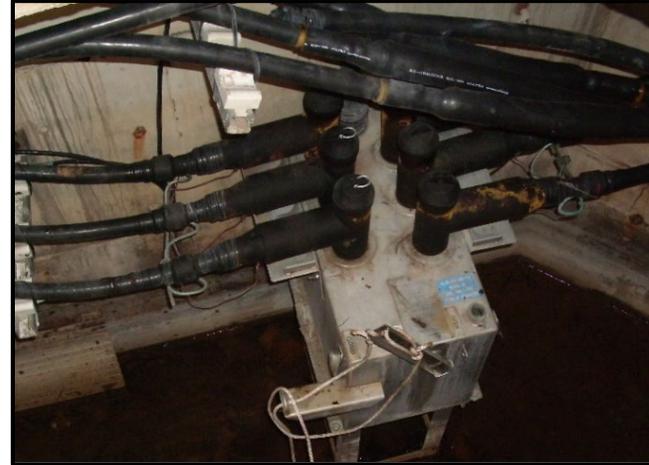
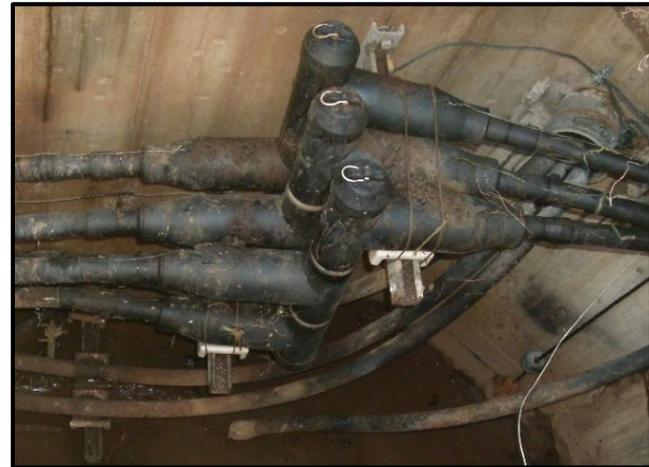
- Manhole and Conduit evaluation:
  - ~40% of ductbank was found to be compromised (not useable).
  - One manhole found to be structurally concerning (old, brick).
- 4.8kV System Considerations:
  - Capacity vs. Cable Size vs. Conduit fill.
  - Vs. 4.16kV system – high TX replacement costs.
- Cable/Switch evaluation:
  - Majority of cable is ~50 years old, past its expected life: Experienced failures 2011.
  - Manhole junction configuration and one mid-way loop switch:
    - Lack of selective switching and increased outage impact.
    - Poor access, operability of manhole junctions.
    - Unsafe mid-point switch

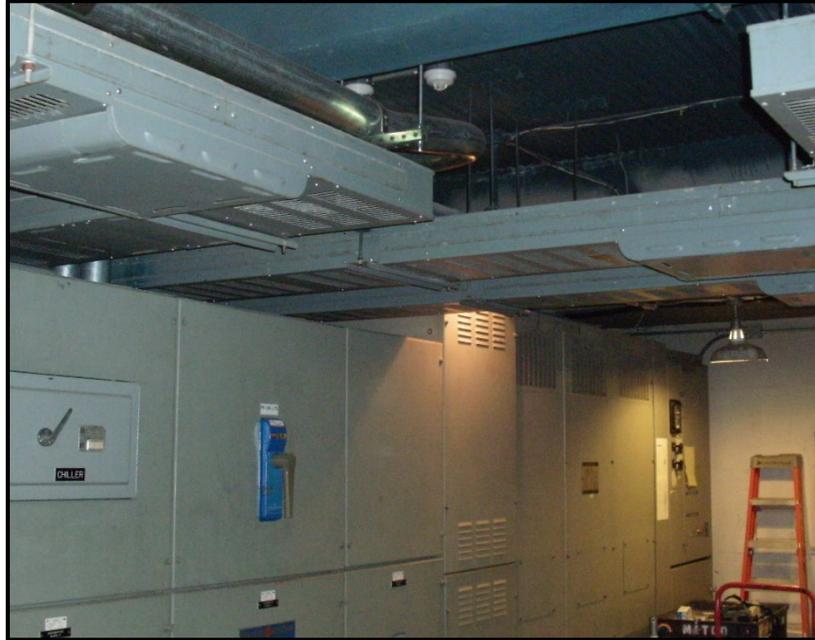
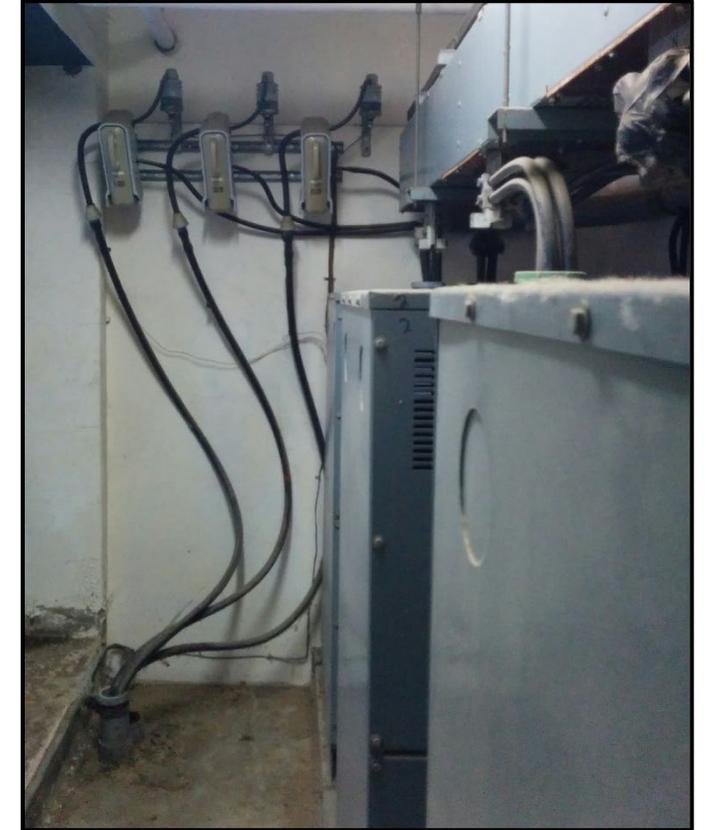
- 85% of building entrances ~50 years old, past design life.
- 30% of buildings had 'extreme danger' arc flash conditions.
- Areas of unsafe equipment or conditions:
  - Manufacturer 'Do Not Operate' direction.
  - Exposed fuse cutouts in E-Room.
