Impact of Combustion Turbine Upgrades on HRSGs

By: Anand Gopa Kumar Analysis Manager, HRST Inc.

IDEA2019 Pittsburg, PA June 24-27, 2019

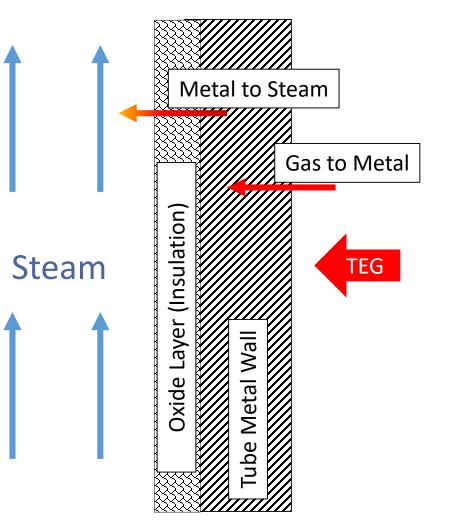
Tube Overheat

- Overheat results in oxide layer growth on the tube surface
- Oxide layer acts as an insulator in the path of heat transfer increasing the tube metal temperature
- Cyclical operation with an overheating tube results in exfoliation and eventual failure

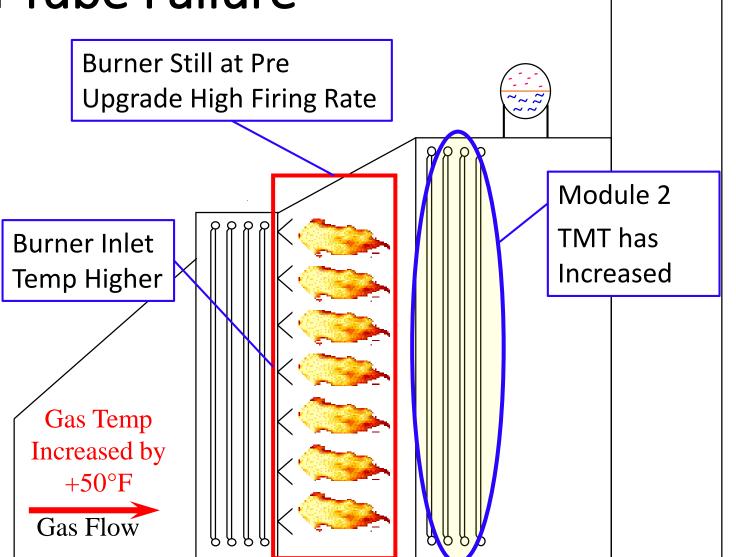
Case Study 1 – RH SH Tube Failure

- Frame 7F unit underwent CT Upgrade
- CT Exhaust Gas temperature increased by about 50°F after the upgrade
- Duct Burner was operating at the same high firing rate after upgrade
- Higher burner inlet gas inlet temp and high pre upgrade firing rate caused burner outlet temperature be higher after upgrade

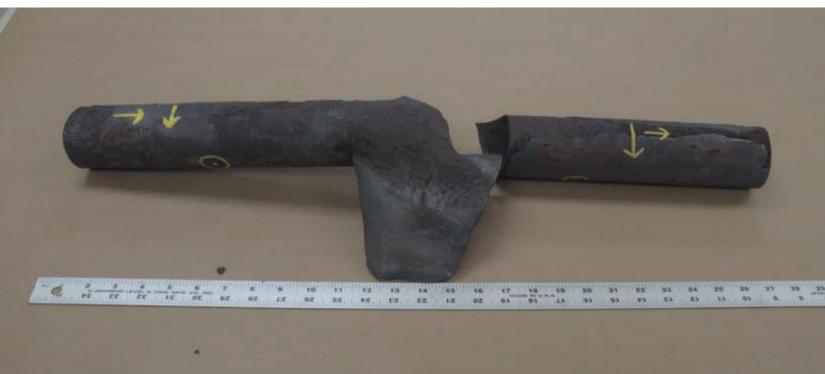
Case Study 1 – RH SH Tube Failure

- Post upgrade operation with high firing rate resulted in failure of Reheater tube immediately downstream of burner
- HRST performed an RCFA of the failure
- Metallurgical assessment revealed failure mechanism as Long Term Overheat

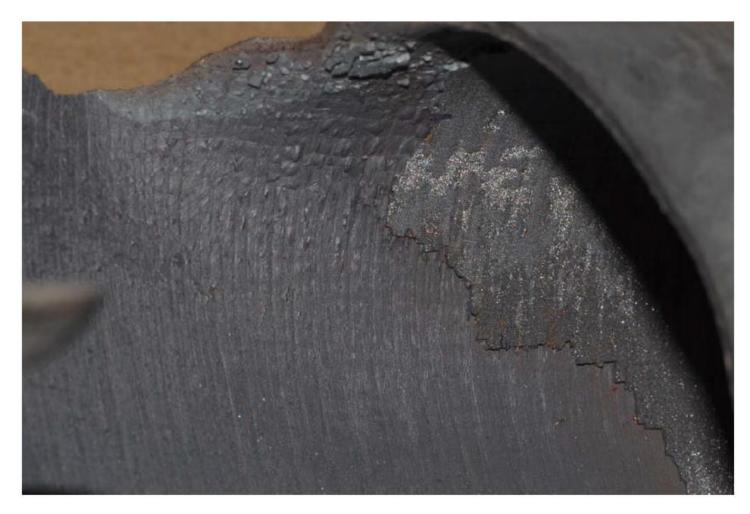
Fissures and Oxide Layer on ID of Tube

RH SH Tube Specs: 2.5 inch OD 0.12 inch min wall Material: T23 (ASTM A213/SA-213) Design Pressure: 650 psig Design Temp: 1119°F

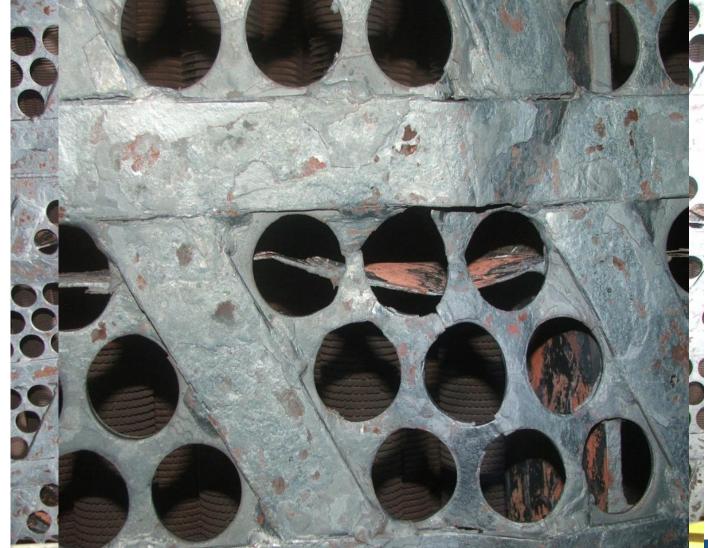
Non-Pressure Overheat

- Non-pressure parts operating close to or above design temperatures
- Areas affected
 - Perforated Plate (Flow Distribution Grid)
 - Tube ties
 - Baffles
 - Flow devices
 - Inlet Duct Liner
 - Firing Duct Liner

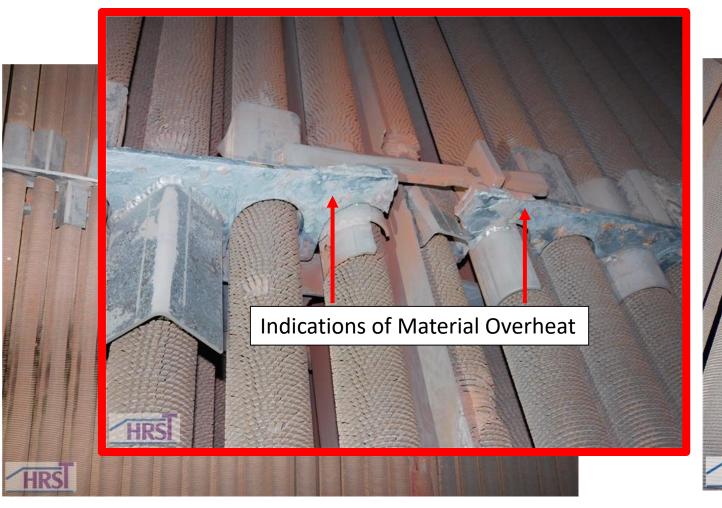
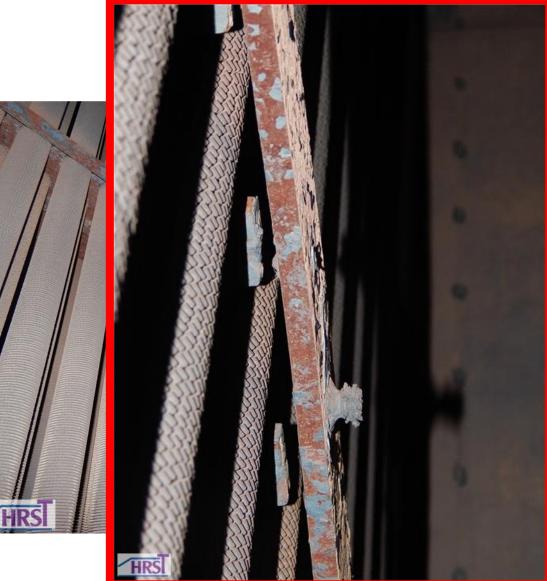
Non-Pressure Overheat
