# How Data Acquisition Helps To Enhance DCP Performance?

Thani AlMansoori - EMPOWER  
Operations Supervisor - Command Control Center

# Case Study – DCP-1

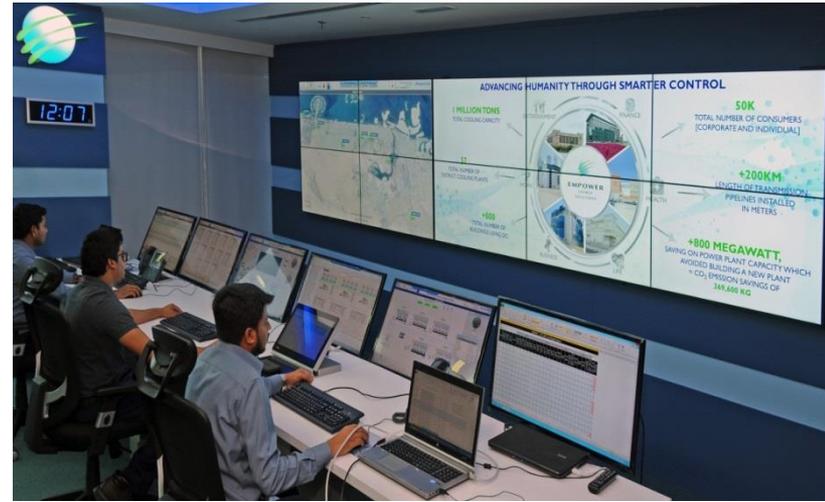
# Command Control Center (CCC)- Objectives

- 1) Remote operation of the DC plants.
- 2) Standardization of DC plant operation
- 3) Centralized data acquisition and archiving.
- 4) Regular analysis of Operation data logs.
- 5) Acknowledging the alarms and notifying to the concern team for rectification.
- 6) DC plant load forecast based on historical data.
- 7) Assist Management for decision making.

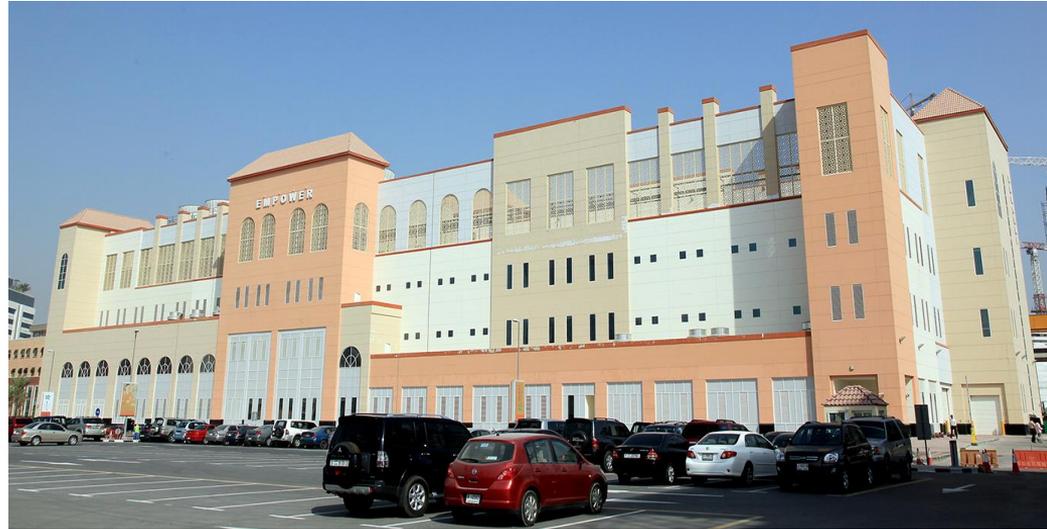
## Plant Overview:

Maximum Plant capacity (TR)	: 56,000
Installed Capacity (TR)	: 24,840 *
No of chiller (TR)	: 12 x 2,070
Plant in operation Since	: Y2006
Chiller Type	: Centrifugal CH comp.

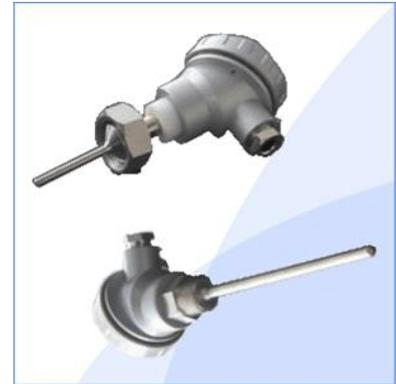
## The Temperature Sensor Verification

Set Point Temp. in Micro bath (°F)	Chiller Leaving Temp. (°F)	PLC & SCADA leaving Temp. Transmitter (°F)
32	32.3	32
41	41.2	41
50	50.2	49.8
59	59.3	58.8
68	68.2	67.8

- ✓ Chiller RTD found okay
- ✓ Header TT also found Okay.
- ✓ The differences are within acceptable limit.

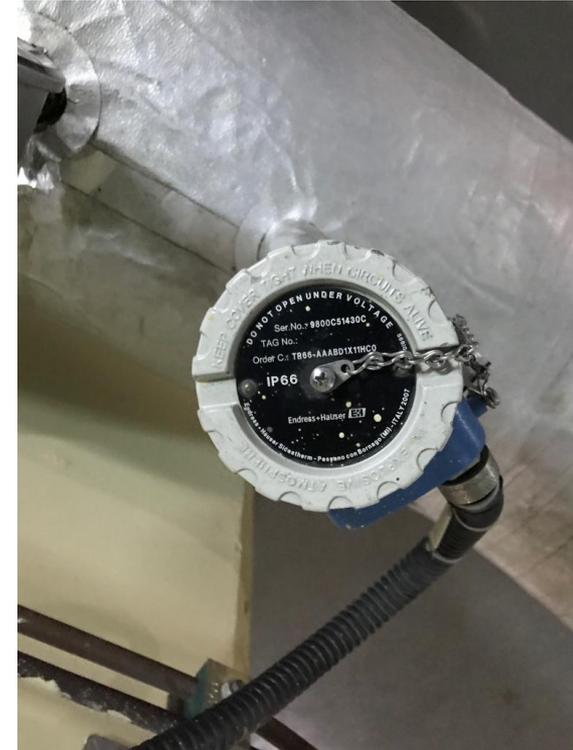
Suggested to shift the Chiller RTD location at a well mixed area (turbulent section, near elbow).

Subsequently shifted one of the Chiller RTD and observed the changes. It shows good improvement.

- ✓ The Chiller RTD shifted near the elbow pipe line, where the CHW mixing well and results appropriate reads to the Compressor control panel.
- ✓ This solution reduce the compressor lift and save electrical input energy to the compressor of each chiller.

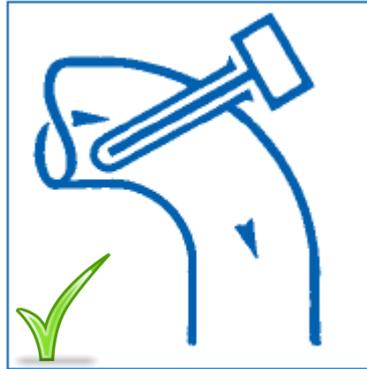
Install Sensors  
At the correct  
angle.
