# Cornell University

## AgriTech Campus in Geneva, NY

### Electrical Master Planning, Substation, Distribution and Building Service Entrance Upgrades

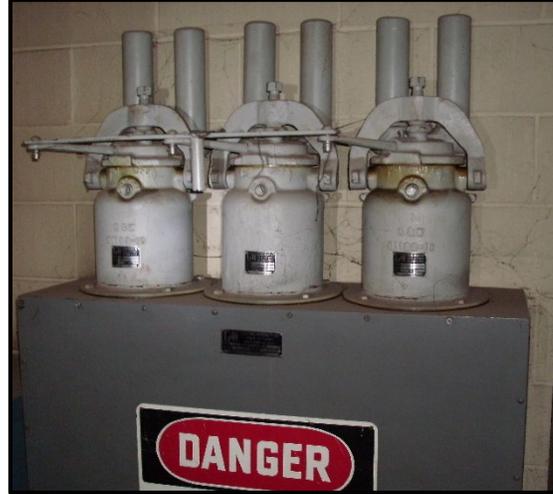
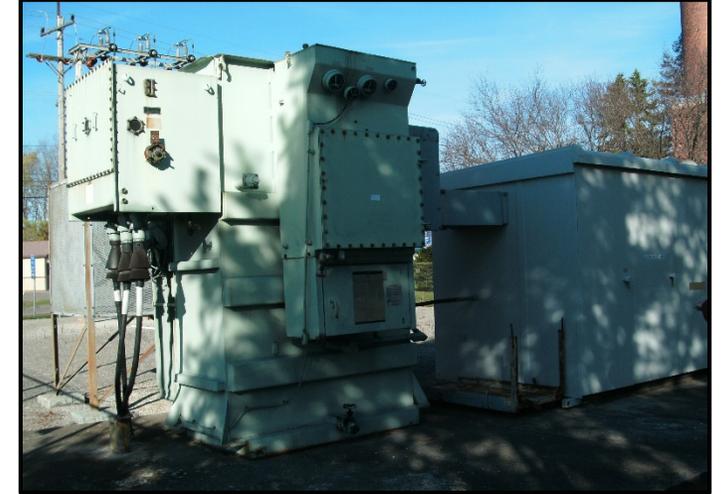
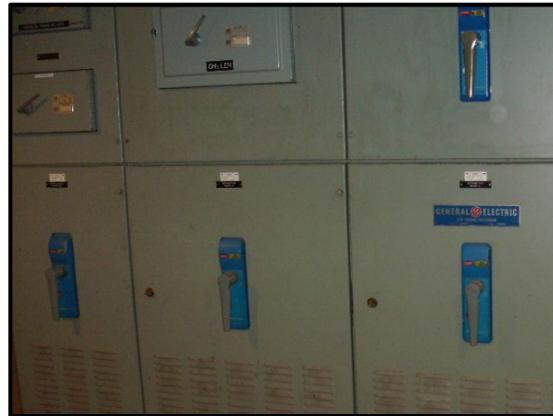
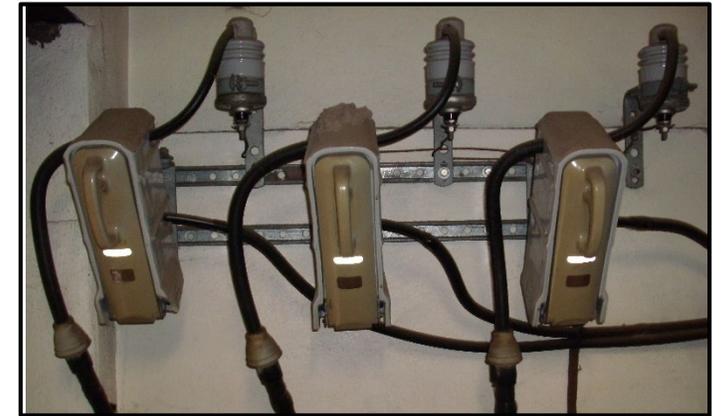
- Inspection of:
  - Main substation
  - Medium voltage distribution system
  - Building service entrances.
- Visual Inspection:
  - Equipment nameplate data age, condition
  - E-Room safety and code compliance.
- Equipment settings.
- Electrician experience and institutional system knowledge.

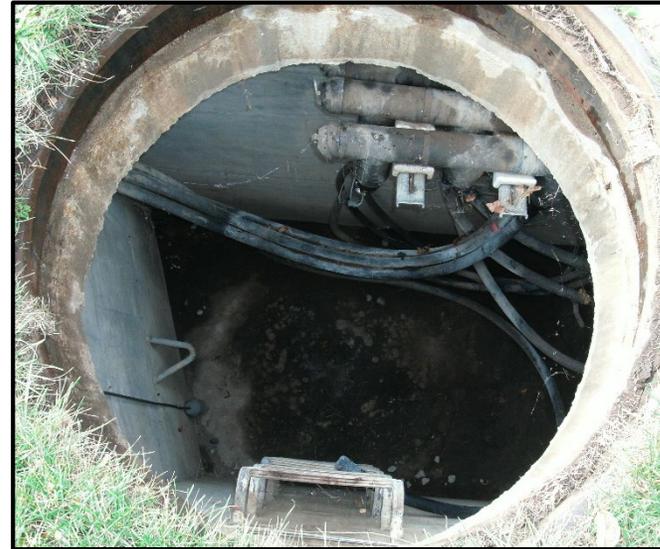
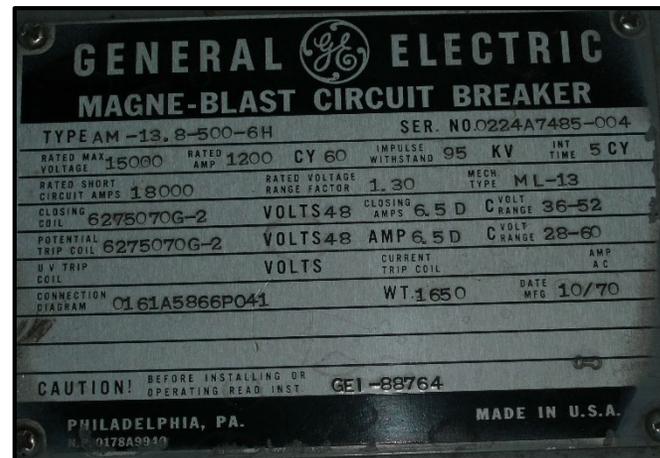
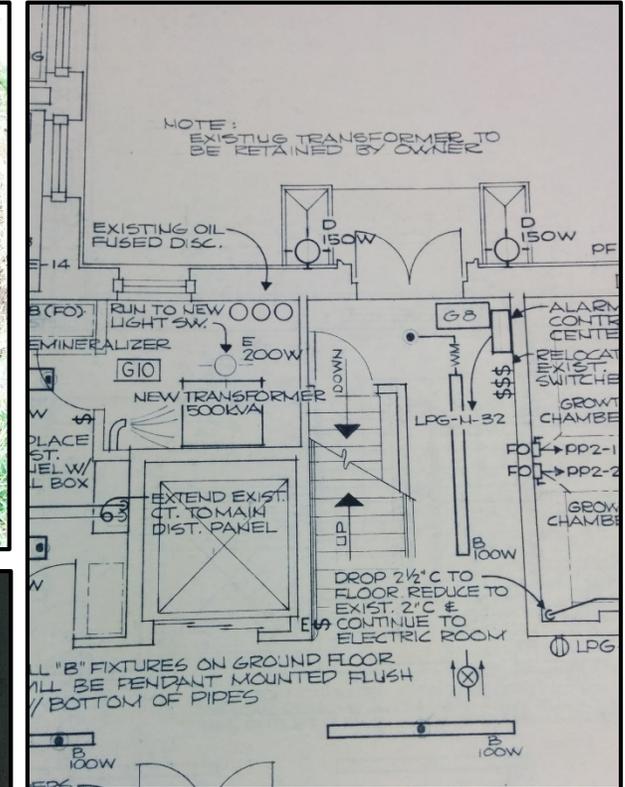
- Site Utility Survey
- Manhole Investigation:
  - Butterfly Diagrams
- Infrared Survey
- Hazardous Material Survey:
  - Asbestos, etc.
- Document Review:
  - Previous studies/engineering drawings.
  - Equipment drawings/manuals.
  - Maintenance records.
  - Historical metering data – load, PF, Harmonics.

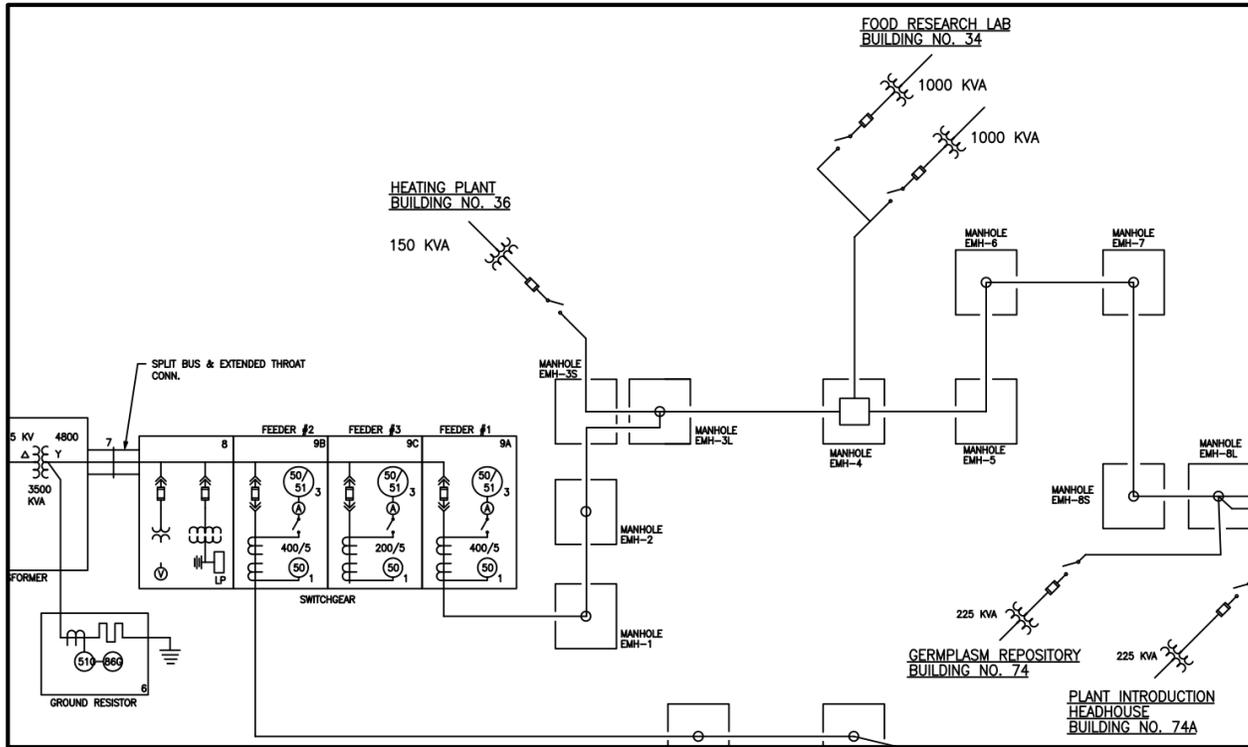
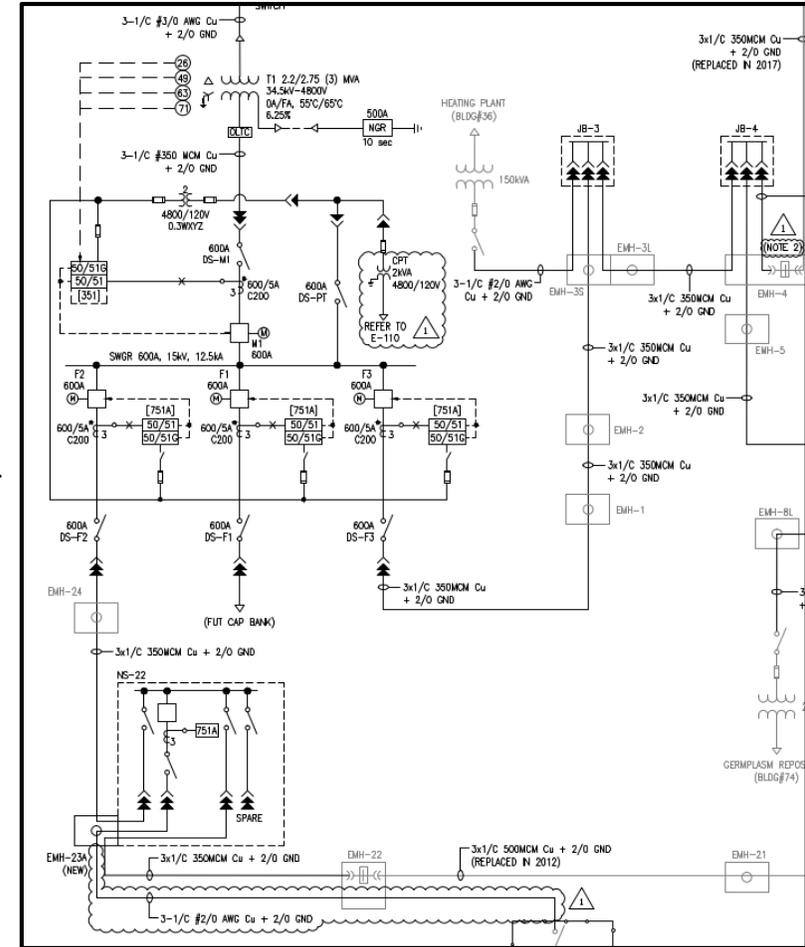
# Medium Voltage Distribution Recommendations

- Manhole and Conduit evaluation:
  - ~40% of ductbank was found to be compromised (not useable).
  - One manhole found to be structurally concerning (old, brick).
- 4.8kV System Considerations:
  - Capacity vs. Cable Size vs. Conduit fill.
  - Vs. 4.16kV system – high TX replacement costs.
- Cable/Switch evaluation:
  - Majority of cable is ~50 years old, past its expected life: Experienced failures 2011.
  - Manhole junction configuration and one mid-way loop switch:
    - Lack of selective switching and increased outage impact.
    - Poor access, operability of manhole junctions.
    - Unsafe mid-point switch

- Replace all old cable (50 years old).
- Install new ductbank, as needed, to abandoned compromised ductbank sections.
- Install strategically placed pad-mounted loop switches to allow for more selective switching and reduce the impact of outages.
- Install pad-mounted junction boxes to provide easier access to remove building junctions during switching.
- Construction phasing switching orders:
  - Configured to replace all cable with five ~4h building outages.

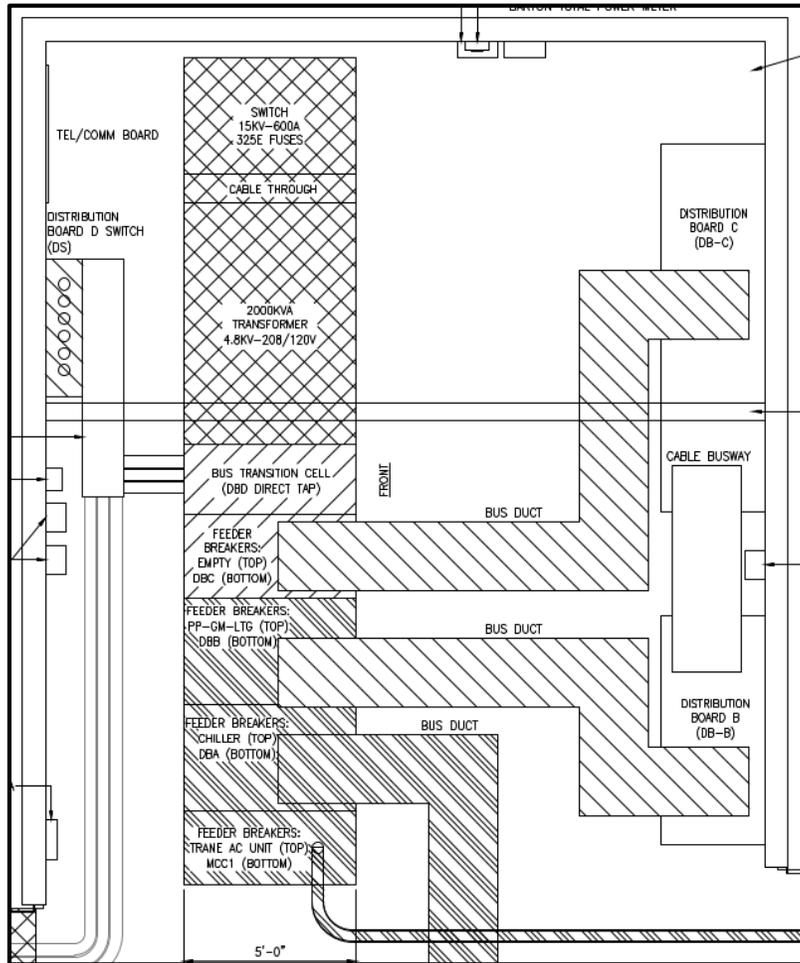
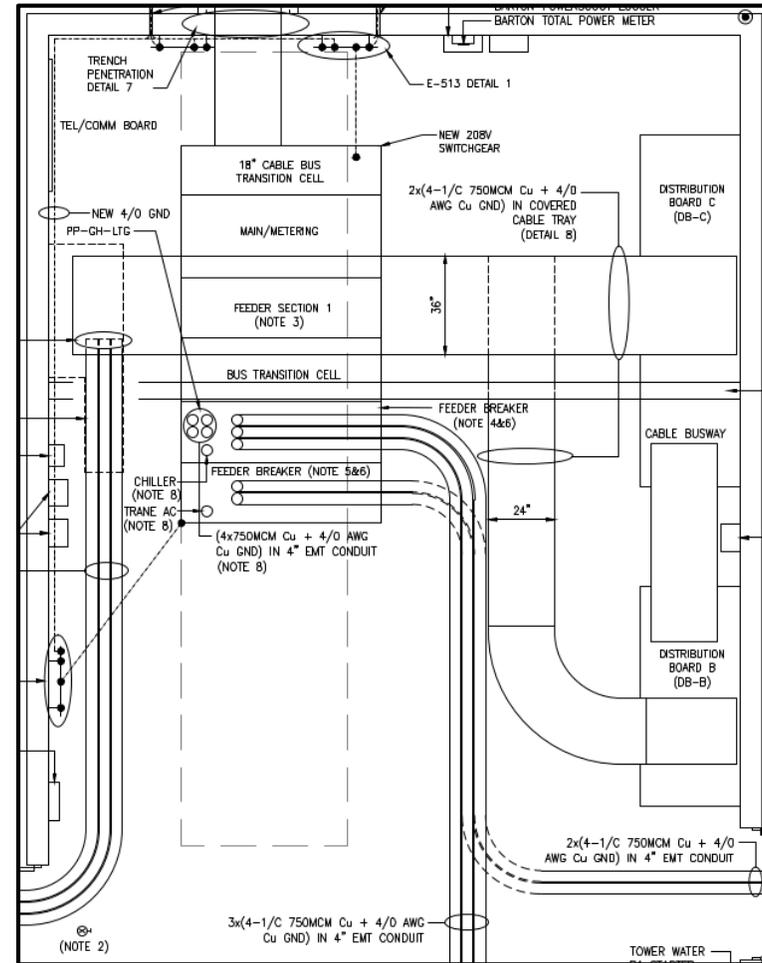
## Recommendations

- 85% of building entrances ~50 years old, past design life.
- 30% of buildings had 'extreme danger' arc flash conditions.
- Areas of unsafe equipment or conditions:
  - Manufacturer 'Do Not Operate' direction.
  - Exposed fuse cutouts in E-Room.

- All services past their design life should be upgraded.
- Priority list of building upgrades produced.
- Top 5 priority buildings included arc flash safety hazards or unsafe equipment conditions.
- Recommended to perform 5 top priority upgrades in one construction package:
  - New MV switch, MV transformer and LV switchgear.
- Construction phasing plans (staged demo/install) produced to install in parallel and use temporary generators to keep all outages to >8h.
